CONNECTICUT RIVER BASIN  
BERLIN, CONNECTICUT

HALLMERE RESERVOIR DAM  
CT 00249

PHASE I INSPECTION REPORT  
NATIONAL DAM INSPECTION PROGRAM

JUNE 1979

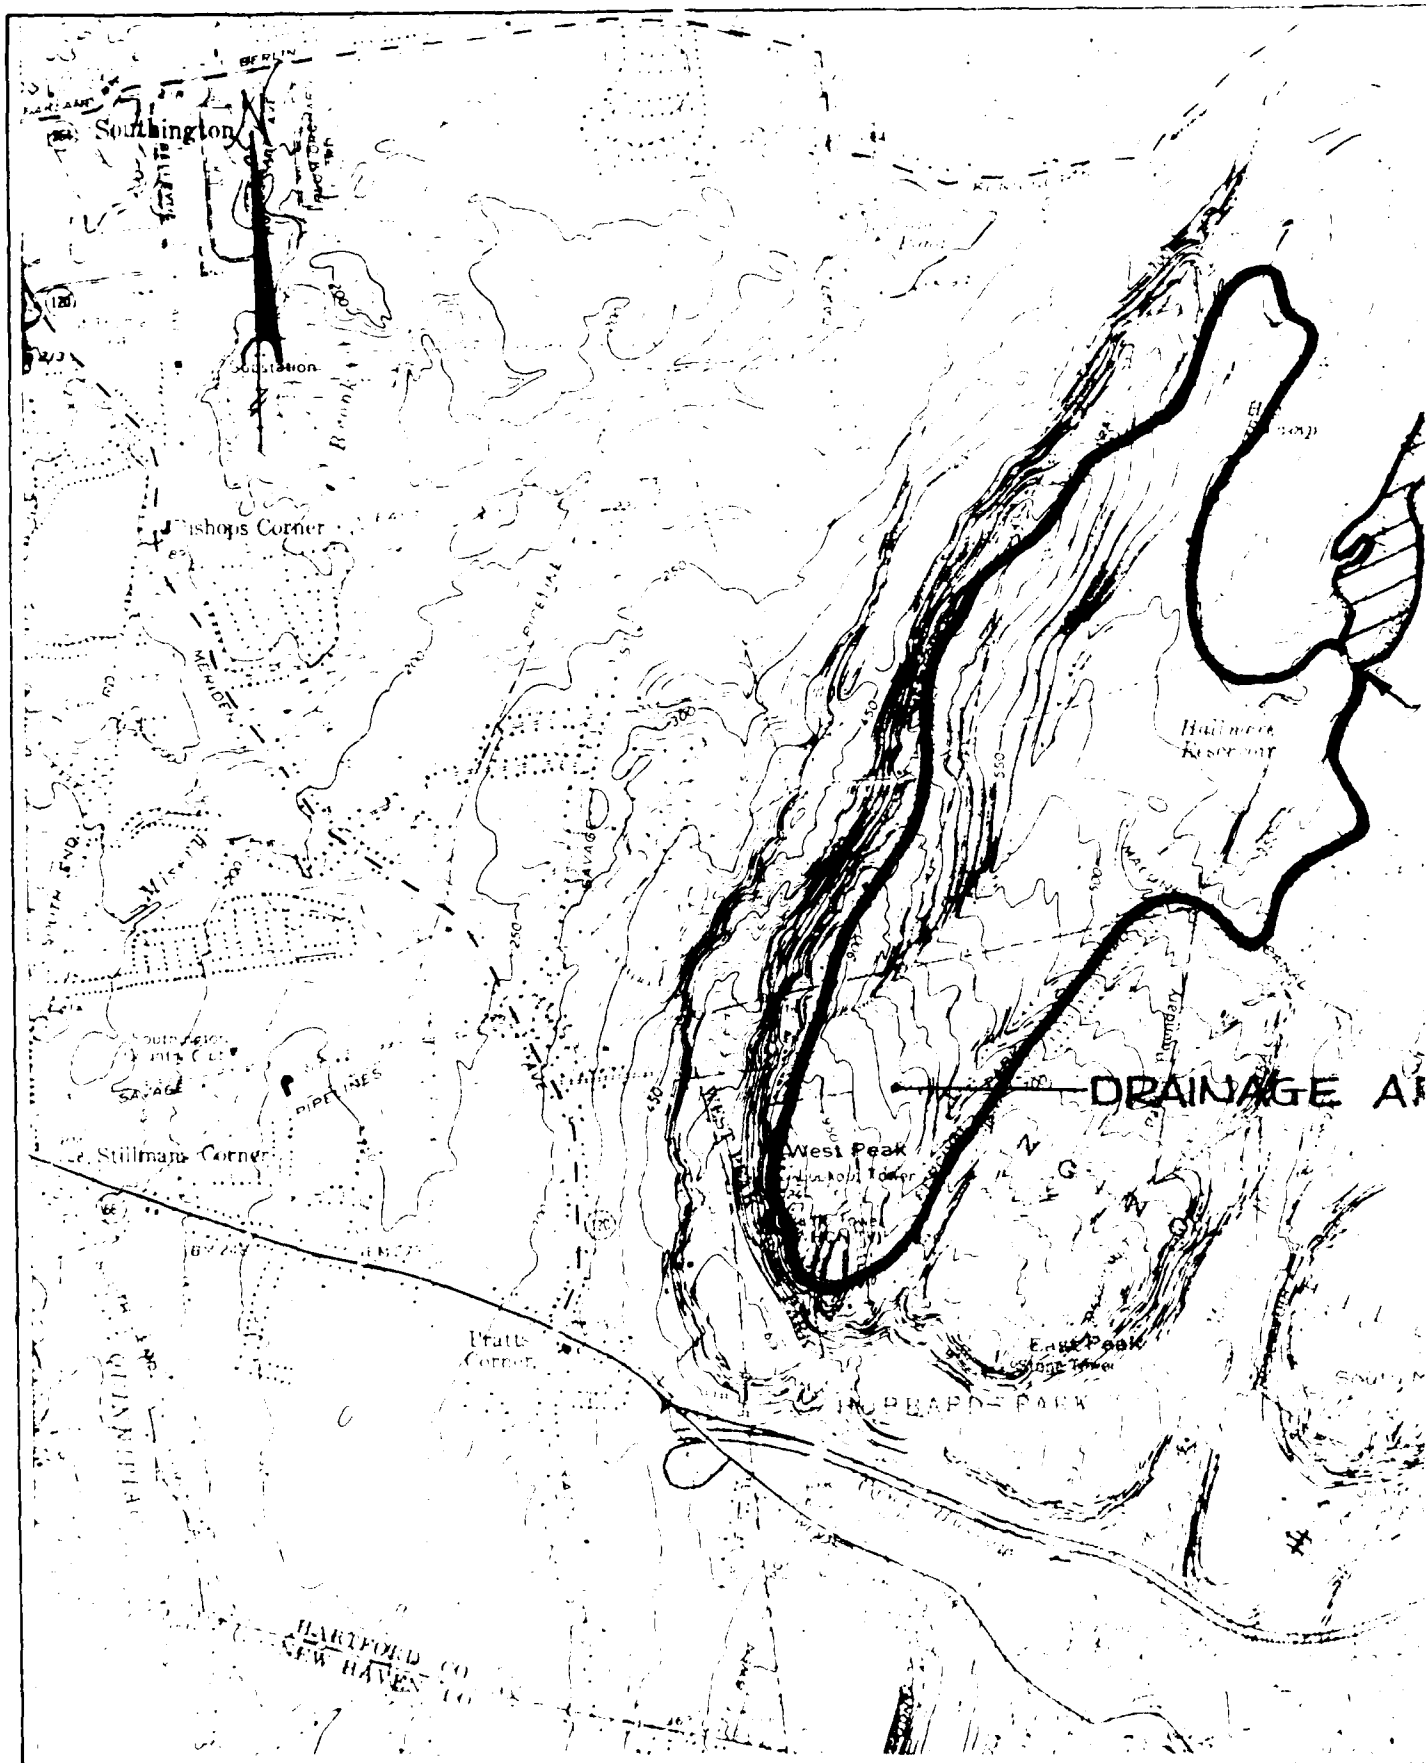
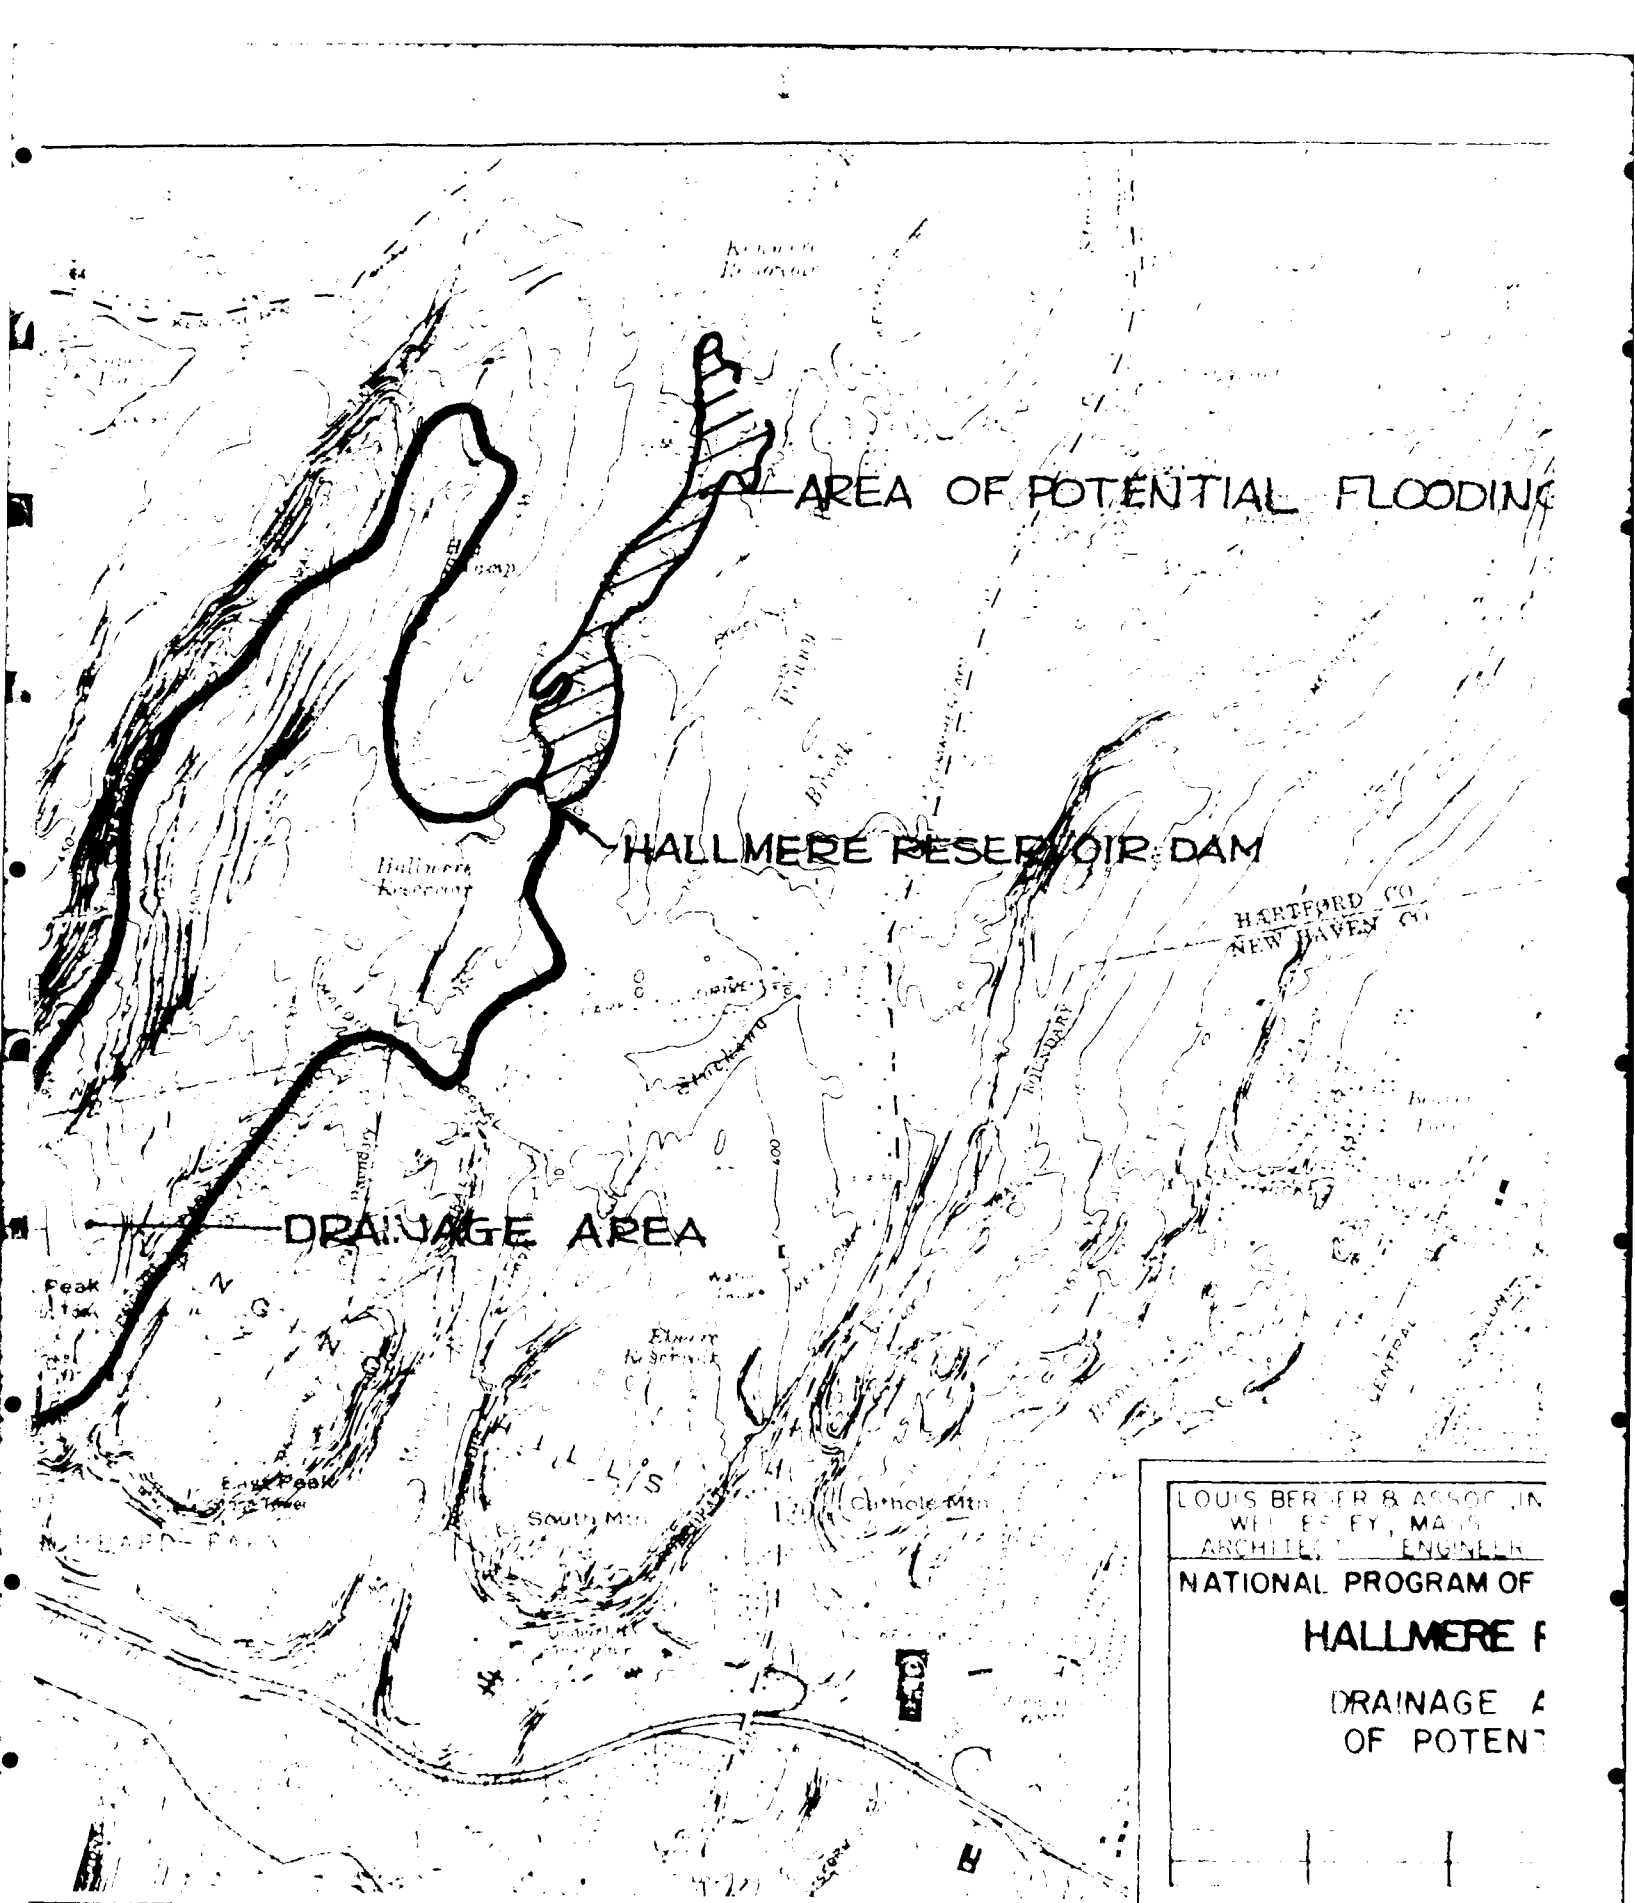
FIG 5

downstream. Flooding due to a structural failure of Hallmere Reservoir as described above would result in extensive damage to about 2,300 feet of Edgewood Rd., to the Algonquin Gas Line (two pipes), and to eleven homes located within the flood plain area (Shown on Fig. 5, Sheet D-22, Appendix D), and would wash out Orchard Road.
